**Ohio
Reserve
Specialists, LLC**

**Reserve Study Update Report
Royal Clusters at Kingsbury Trace
Homeowners Association
Copley Township, Ohio**

May 2013

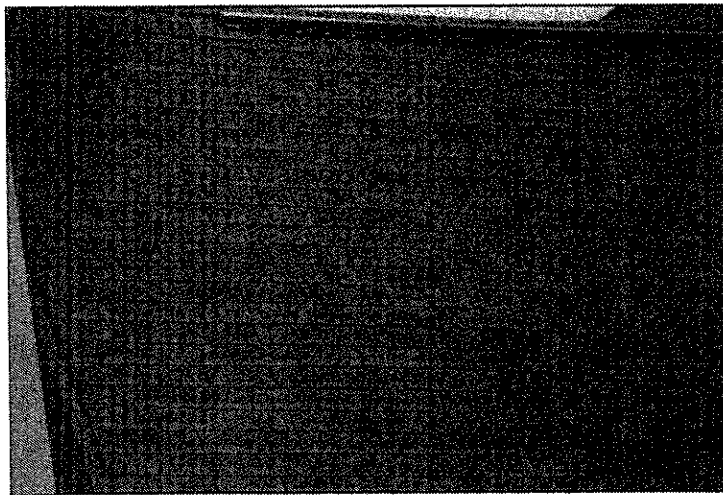
Shingles in photo at left
continue to lay flat &
appear in good condition.

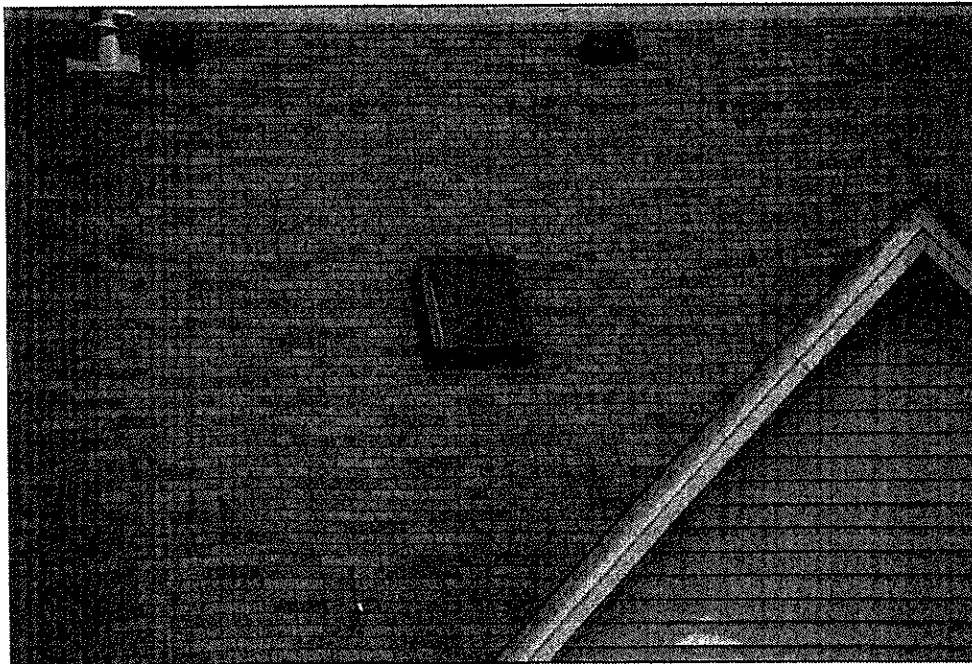
Some cracked or lifted shingles are noted in photo below.

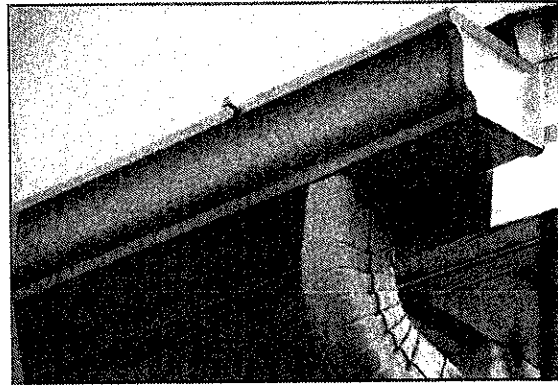
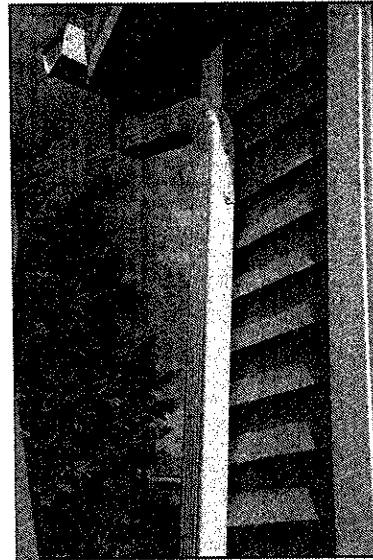
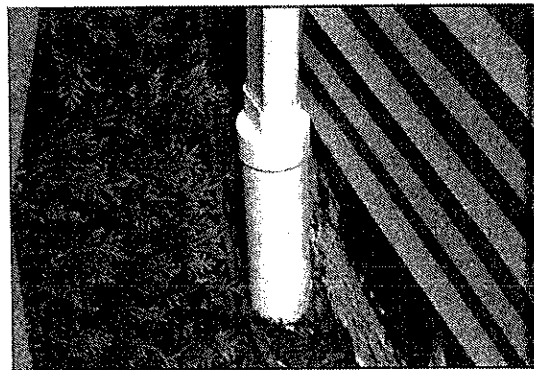
Typical gutter & downspout configuration is shown below. Loose gutter ferrules should be re-secured.

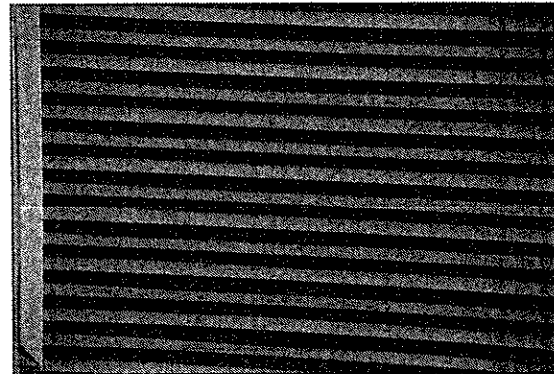
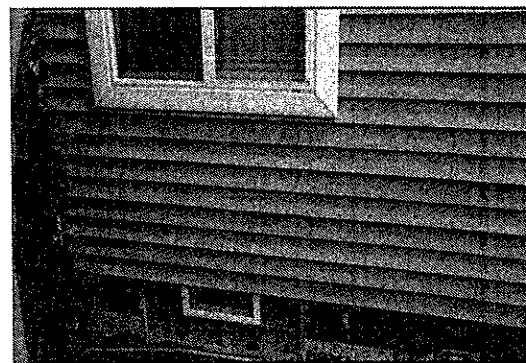
Typical vinyl siding & window trim is featured above & below.

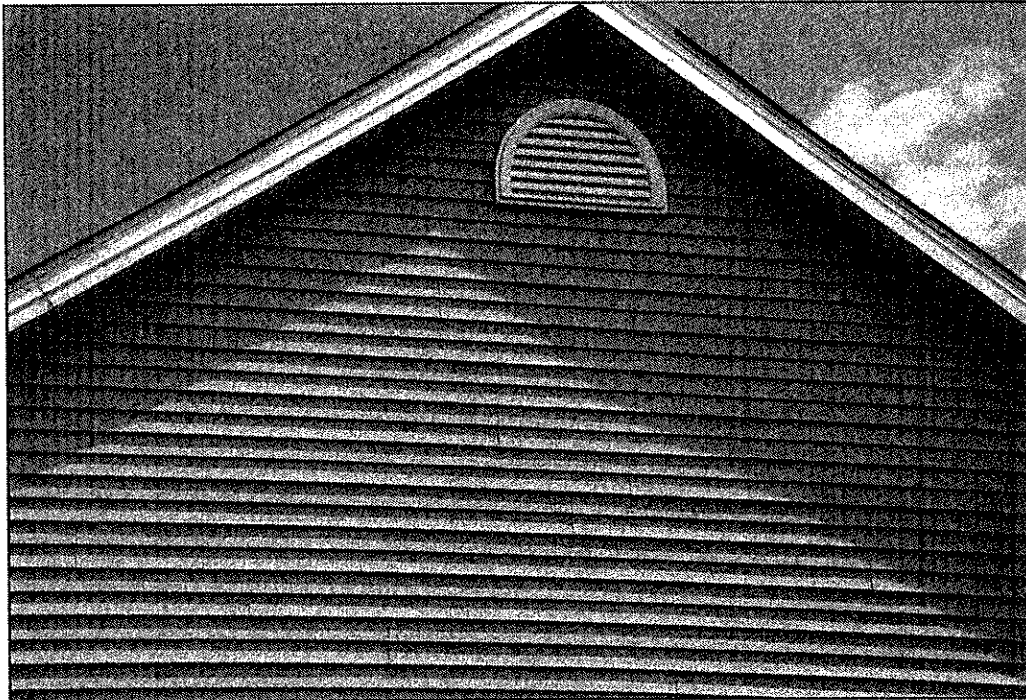
Typical style & condition
of vinyl siding is shown in
photo above.

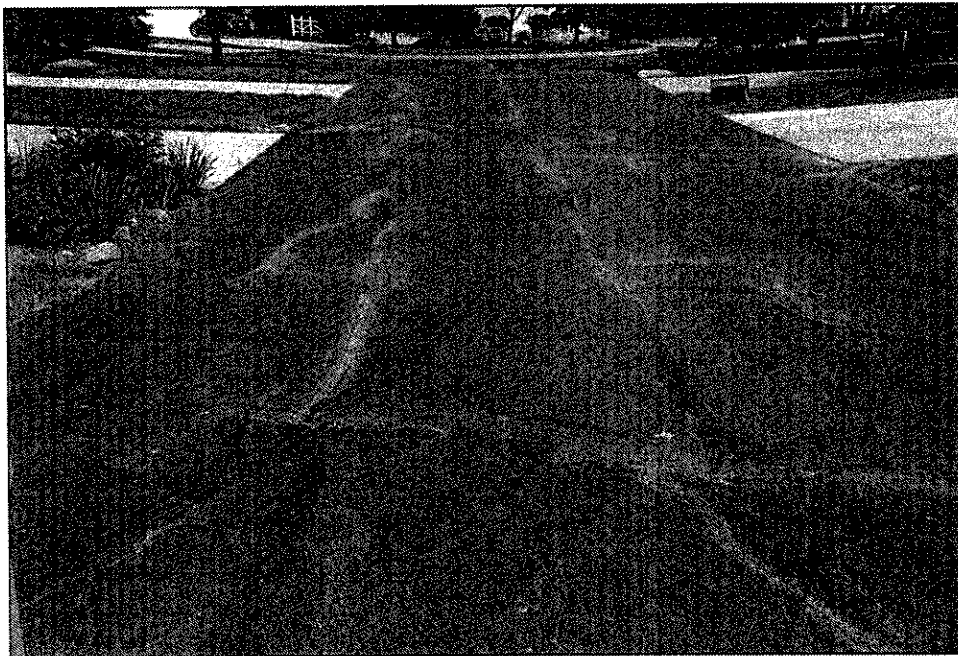
Crack filling and sealing is evident in photo above and is consistent throughout the property.

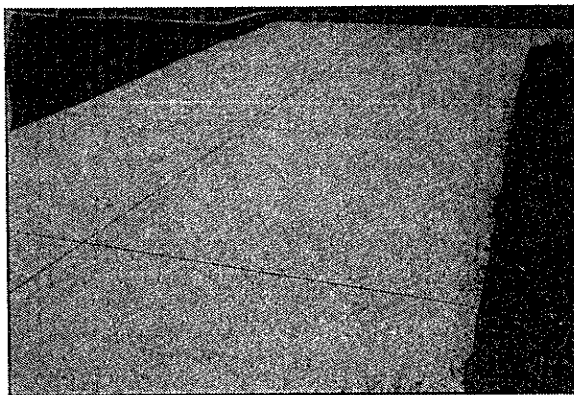
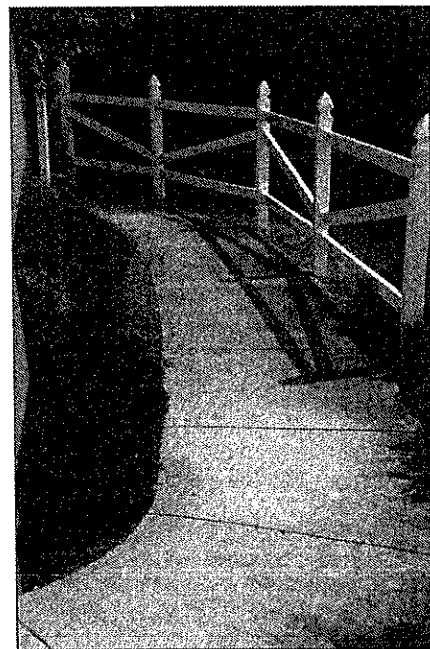
Any cracked concrete sections should be filled or repaired to prevent unwanted water penetration especially during the winter months.

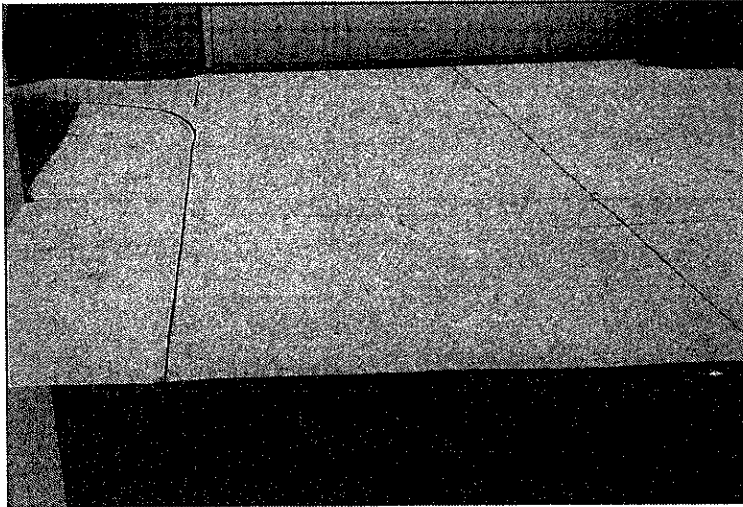
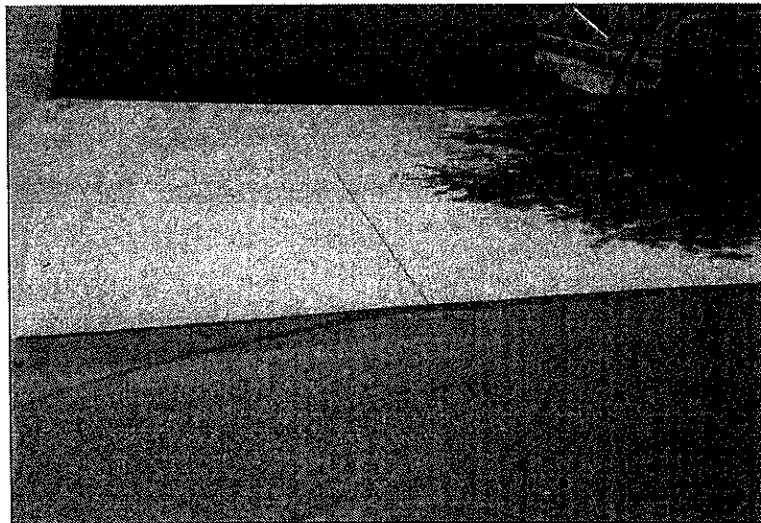
Typical concrete driveway sections are shown in photos on this page.

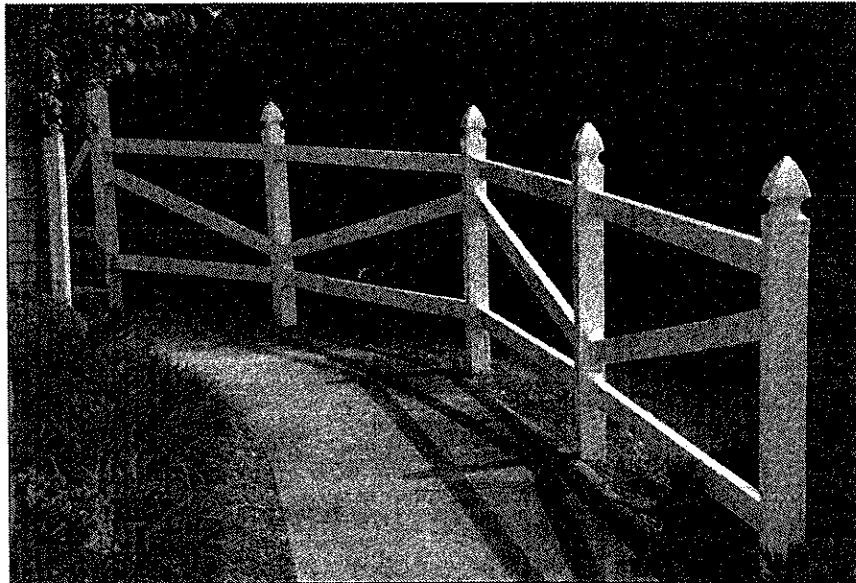
A newly installed section of vinyl fencing is featured in photo above.

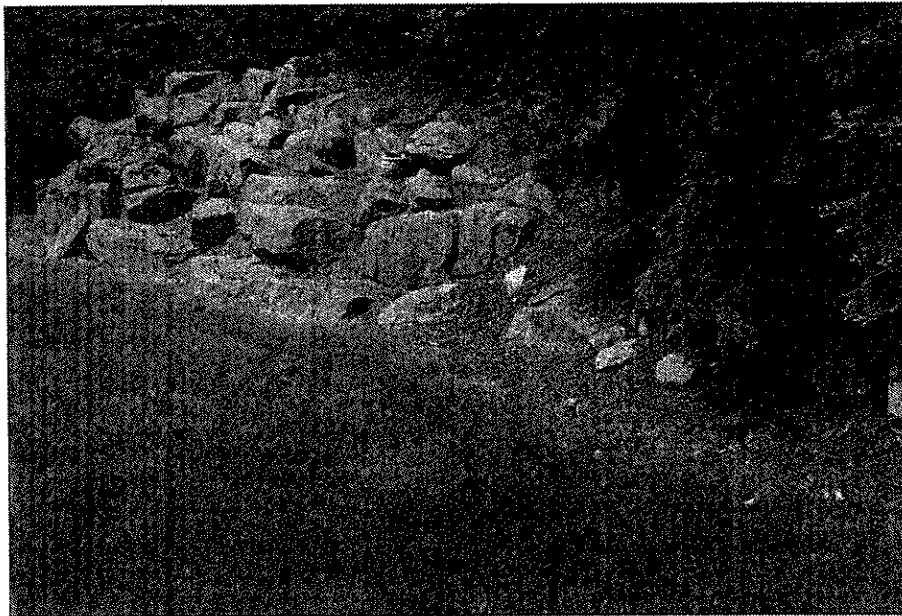
The boulder retaining walls found through out the property were found to be in good shape due in part to several separate repairs that were completed in 2009 as the result of wash out and shifting boulder walls. The walls primary function is to prevent erosion of the soil in the areas of the property where there is a major slope change. All of the areas over time may need to be partially repaired, however this will depend highly on drainage in the areas, weather conditions and how well the drain system is maintained. We recommend accruing \$4,000.00 dollars every ten years adjusted for inflation to reposition portions of the walls. This cost includes repositioning only. Any drainage repair or additional boulders being added would need to be quoted individually. The amount used is an estimate to place equipment and restack approximately twenty tons of boulders.

One of the several
boulder retention walls
is featured above.

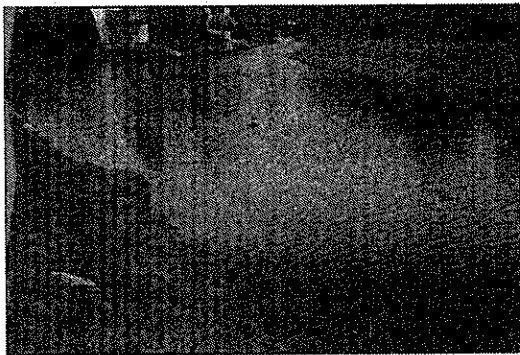
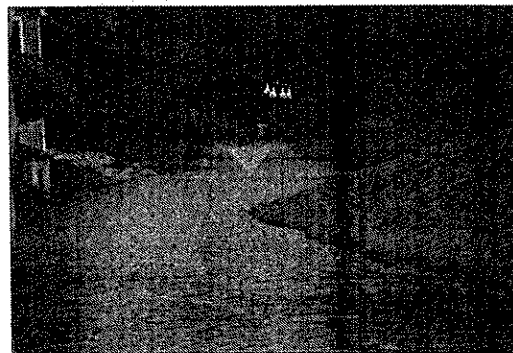
Retention ponds and associated elements are shown above.

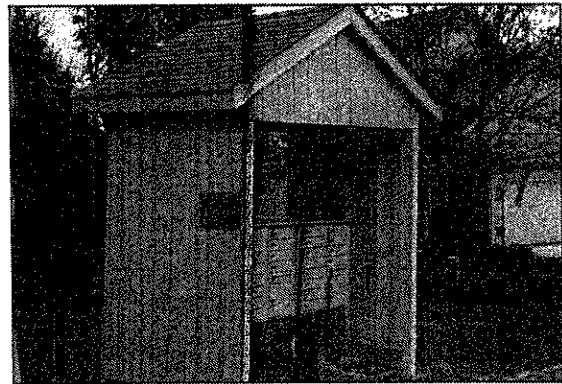
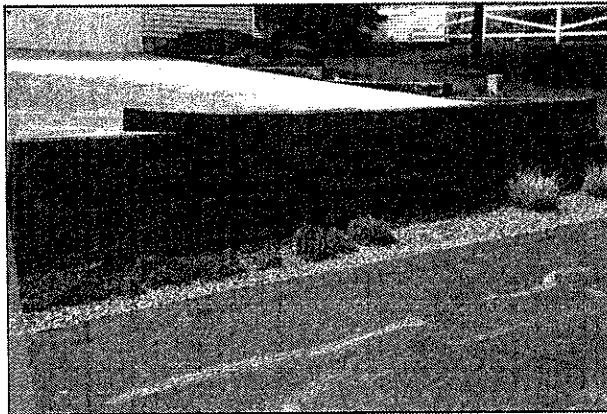
Typical condition and examples of wood retaining walls and mail huts is shown in photos on this page.
